Behind the Wheels Podcast Transcription Season 2, Episode 4: Wheels of Shame Part 2

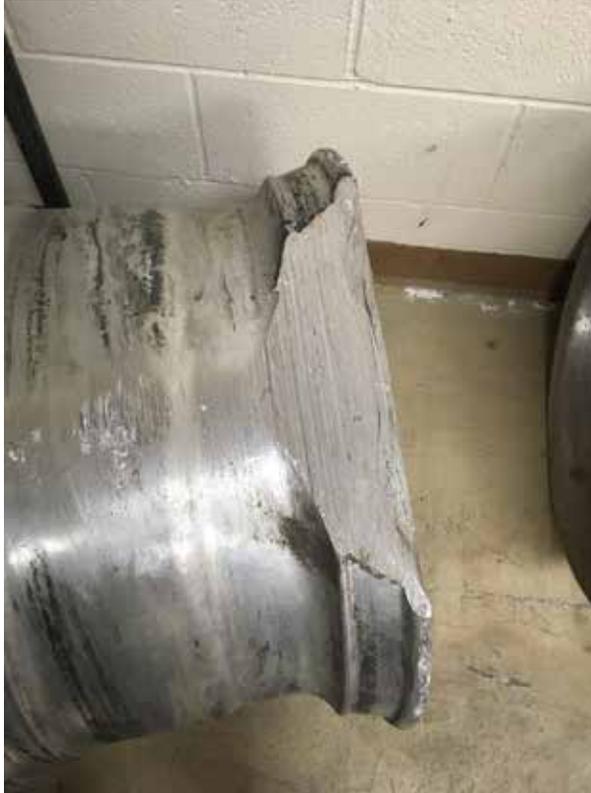
Okay. Basically, on a wheel, this is a big flat spot. And what happened to this wheel, it's a wide base, and it had a tire blow up. You blow out a tire, the first thing you start to think about is hitting the brakes. Well, when you hit the brakes and you don't leave up on the brakes, you're dragging that tire along the pavement as you're trying to get the truck to stop. And basically, it got really hot and he took away a bunch of metals, so there's a humongous flat spot. And when the guy called us, his comment was, "yeah, I blew out a tire and yeah, I hit the brakes, but it's got to be soft metal." That's our favorite comment, always tell you, "it's got to be soft metal."

And being in the aluminum wheel business for the past 32 years and then when you explain to them the heat treat process and all the bells and whistles that we put into making these, it is not soft metal. So it's a very interesting one to see how hot the wheel can get in a very short time when you're hitting the brakes and running across pavement.

What it reminds me of, Dave, is, if you want to visualize this, you get a huge chunk of sand paper and a circular piece of wood, and you start sanding that and just how you can remove the material so fast. Basically, I would imagine this is probably on an asphalt road where they did this and it looks like it was just sanded right off. When you get a chance to look at the pictures, if you guys go on to the notes, you'll see that this is about a nine-inch section of the wheel that's removed. The flange is just gone. So yeah, it's very impressive to see, and obviously if it was a soft wheel previously, it would have deformed and not have been removed like this here.

What happens is you heat up the metal and then the metal gets soft, it loses that T6 heat treat. What can happen is that the wheel will start shrinking on the open end, and it's the wheel is soft. It just starts shrinking a little bit on the open end and won't be able to hold the tire properly. If you drag a wheel with a load on it over asphalt, and it looks like this, that is not a soft wheel. That is a wheel that's been ground down to nothing, and that's exactly what this looks like. And I guess before somebody goes and starts talking soft wheel, you really need to understand what a soft wheel is. Soft wheel comes about because of heat and this is mechanical damage that we're looking at here.

Just to say, yeah, you're just going to get deformation if it's a soft wheel, if you've overheated the wheel in some way, like you said, it's just going to deform. It's not going to be removed like you see in this picture.

Well, unfortunately With wide base, this is a wide base wheel, if you have a blowout, and this is one of the things that a lot of companies don't like about wide base, when you have a blowout with a wide base, that wheel's going to hit the ground and you're going to ruin the wheel. A lot of these guys used to tell me, road calls are extremely expensive, but you're not only buying a tire, which a wide based tire could be \$12 to \$1,500. You're buying a wheel, you're doing a road call. I mean, it's very expensive with a wide base. Now the benefit of course, the wide base is hauling more payload, but on a wide base that happens. Now, a lot of times what you see, this driver was on the brakes hot and heavy. A lot of them will hit the brake and then let up a little bit and hit it again.

It's just really their training. So, you might see two flat spots on a wheel and you're saying, "well, he hit his brakes once and then he hit him again." But on a wide base, unfortunately, you're going to do that. Now on a set of duals, because you have two tires and you have a blowout say on the outer dual, the chances of hitting the asphalt is slim to none because you still have the other one and vice versa. So, duels, you don't hit asphalts. Wide base you definitely hit asphalt.

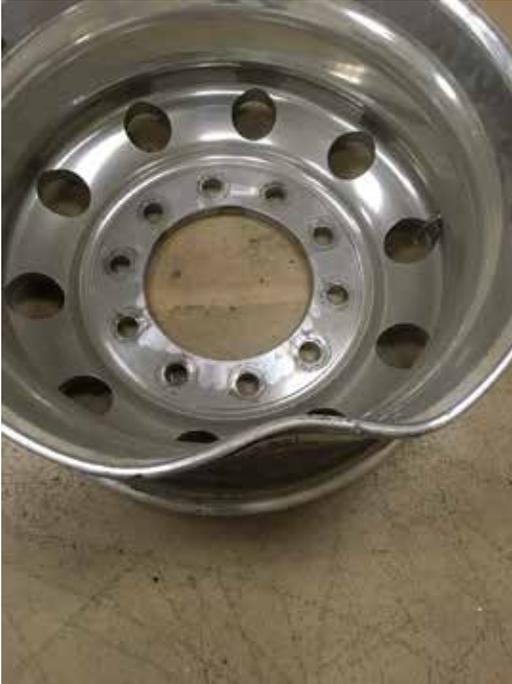
Well, this one really is interesting from the standpoint of how much deformation we're seeing here. If you can think of one of our dual wheels and you have the open-end, you typically would see a nice round surface. Well, think about going around that outer rim and all of a sudden you have a tremendous dip in towards the hub and then continue on around the wheel. And this is really some real heavy impact situation where the flange has been bent dramatically, and we presume that they would have had air loss on this situation as well. And so, this is just the amount of force and what they would have run over or hit, not exactly sure. It looks like it only hit the flange, the open-end flange. It doesn't look like it hit the inboard flange from the picture. So that would be what you would describe this as, is just a large deformation that caused an unseating of the bead of the tire and created a flat.

Yes. And the reason I've kept this one, because either I talked to the customer personally when we rejected, or one of my people do, but this one was probably the funniest conversation I had. I called the guy and I said, "we're not going to warranty this because it was an impact hit," and he says, "well, I hit a moose." And I'm like, "You hit a moose!" He says, "yeah, but I missed it with my front, I only hit it with my duals, and I don't think a moose could bend that wheel like that." And I'm like, "a moose is like hitting something bigger than a horse. We definitely don't warranty against mooses."

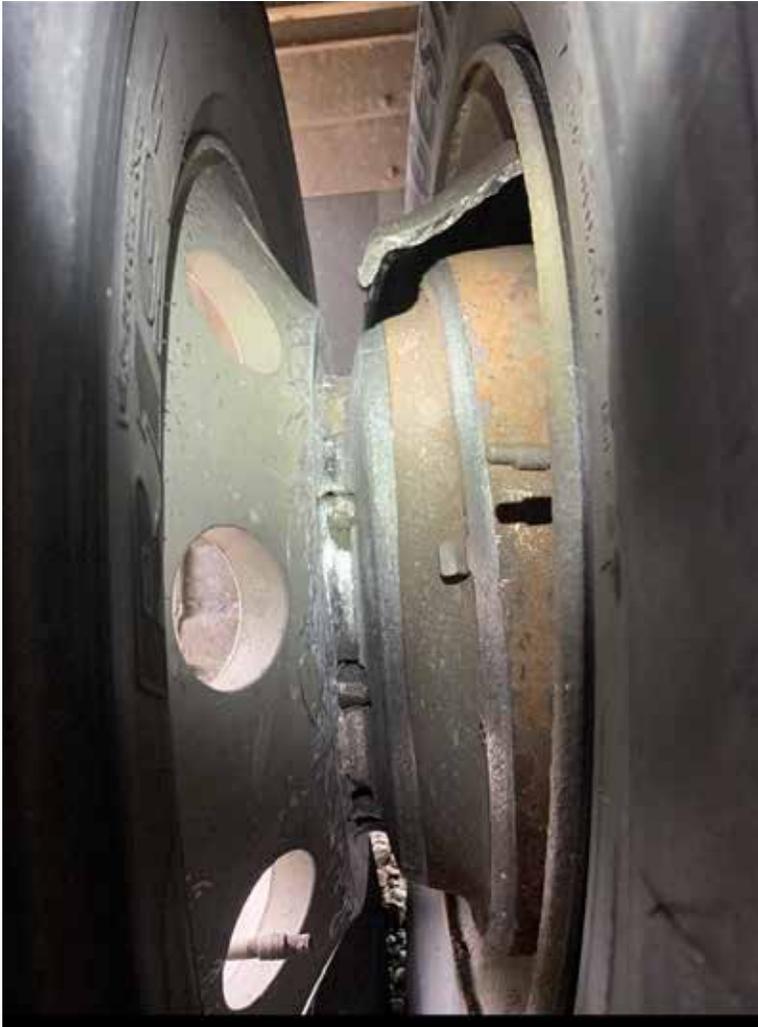
That's funny. Let's move on then. And I guess this one is also very interesting because it's a picture of an aluminum wheel and a steel wheel duel with the steel wheel not looking so good. And Dave, I know that you really gave me some good insight when we first looked at this, so I'm going to turn this over to you again as to what happened here.

I don't like the steel inner and aluminum outer. I know a lot of people run steel inners and aluminum outers, and this is what I'll tell in my story when I would go out and do training programs. Steel wheel flex rate, compared to aluminums are totally different. Steel wheel flexes are a lot more, they're thinner. They're not as strong as a forged aluminum wheel. So, what you have is you got two different flex weights. So even at the same air pressure, you got different flex weight. Then you put a steel wheel on the inside where it's harder to get to the valve STEM, especially when you're running an aluminum wheel to get to the valve STEM and say, you don't have the right air pressure. One of those wheels is flexing a lot and the other one isn't. So, when the steel wheel breaks out, it breaks out.

I mean, completely this one's got chunks missing of it and it breaks apart. And not only are you ruining your wheel on the inside, you're probably going to ruin your wheel on the outside. And a lot of times you can even ruin a tire or brake drums. So steel wheels and aluminum outers is not an application if you're, and I'll put an asterisk between this here, but if you're hauling very light loads and I mean, light loads like fiber glass or something like that, you're not hauling, your max load is maybe 15,000 pounds, you might be able to get away with it. But boy, if you're all in 80,000 pounds of steel inner and aluminum outer, it's going to cause you problems down the road. So anyways, that's what this picture is.

So basically what's happened here is you have the ongoing flex, and you have just a hell of a lot of flex of that inner steel dual, and it just looks like it's broken into pieces. There's nothing left of the mounting flange that I can see. It looks like it's completely all gone.

It looks like there might be a little bit holding the aluminum wheel in position from the inner of the bolts circle or along the bolts circles, kind of what I see. And so they're fortunate actually, that that is still there or the outer would be wobbling all over the place.

Most of the time, the whole center breaks out of steel wheel and then it starts flopping around and that's always the aluminum outer and it can even get the tire and can even get the break drop. People always say, steel inner and aluminum outer, the flex rates are so greatly different. I mean, aluminum wheel, the thicknesses we make on aluminum wheel, forged aluminum wheel, there is no flex, where steel wheels are endlessly flexing as they go down the road.

Right. That makes a lot of sense. That's just for our listeners knowledge. And aluminum wheel and the mounting flange will be typically about twice as thick, maybe a little bit more, maybe a little bit less, but in the hand hole area and the disc face there, it gets real thick compared to a steel wheel. And in this picture, you can see the wheel thicknesses, you can easily see the wheel thickness of the steel wheel and compare that to the aluminum wheel. And you'll see, it looks like two or three times the thickness, at least from the same angle. The aluminum wheel is like two to three times the thickness of that steel wheel. And although steel is strong, the mechanical properties of steel are certainly strong, there's some times that that thicknesses, especially when you're talking about stiffness, nothing helps like just having thickness there, having that mass, or I would say the dimensional thickness is what really stiffens things up.

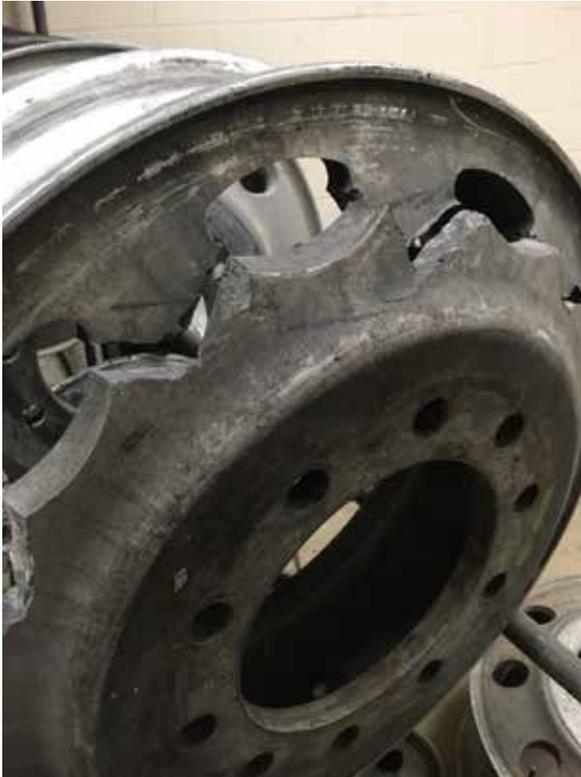
Okay. I'll try and explain this one. This is a, basically this is a stylized wheel. And when we say stylized wheels, typically our wheels have just round hand holes. And this one has hand holes that have some shape to them, it's elongated hand holes, that's how it's designed. So, the wheel has these longer hand holes. And then what looks like has happened is the wheel broke from hand hold to hand hole. So, there's a crack that went from one hand hole to the next hand hole. And I guess from an engineering standpoint, I find it interesting the way it cracked. It cracks down toward the hub and then goes back up toward the next hand hole and then down towards the hub, sort of making a zigzag shape as it works its way around the wheel. It looks like the photo only shows like four or five handholds here, but it looks like the entire mounting section of the wheel is removable now, that it's been broken 360 degrees all the way around. So, Dave, any stories behind this one?

Oh, absolutely. Like I said, I only ever kept wheels that I really found a great story. This is actually from a coal hauler. And this coal hauler, I really don't want to mention the state, but in this state, they were very brazen about overload. And the one time I was down there and he had this wheel and I'm like, "wow, the loads that you're carrying," and he's like, "no, I'm really doing a good job. I'm cutting my guys back." And I say, "well, what do you mean you're cutting your guys back?" He says, "cutting them back to 90 tons." I said, "90 tons? [inaudible 00:17:45] Anything over 90 I'm not paying them for no more."

And I'm thinking of the whole tractor trailer, he's talking about just the load. The legal payload is 23 tons. "You can't make no damn money at 23 tons" is what he said to me. So, I'm like, "Oh boy, here we go." And I'm like, "I think you need severe service wheels and there still won't be in warranty." Needless to say, the DLTs in the state now don't allow that kind of stuff to happen anymore, but this is off a coal truck. And if you look at the wheel on the photo, it's as dirty as you've ever seen and smashed. And we always say poor inspection protocol. You know what I mean?

To allow it to get that far, but it brings up a very good point about just overload in the design of the wheels themselves. I mean, these are designed very, very carefully and there's a lot of technology that goes into them. A lot of testing accelerated testing at high loads to ensure there's a margin of safety. And so like you said, Dave, you go out and you take a look at these things and you know that the wheel is designed to handle the load the vehicle is rated to, the axles are rated to, the tires, everything, the whole system together. And I'm presuming that if they're having issues like this with the wheel, they're probably having issues with other portions of the whole suspension as well. That's a tremendous overload.

Now, again, I'll say this is going back because that state now has basically told them, hauling coal is allowed to run a hundred thousand pounds vehicle coal, everything. From 180,000 pounds payload, plus another 25, 30,000 vehicle, two tens, two twenties. So now they're down to a hundred, so we're going in the right direction. But we do make severe service wheels and I always stress that.

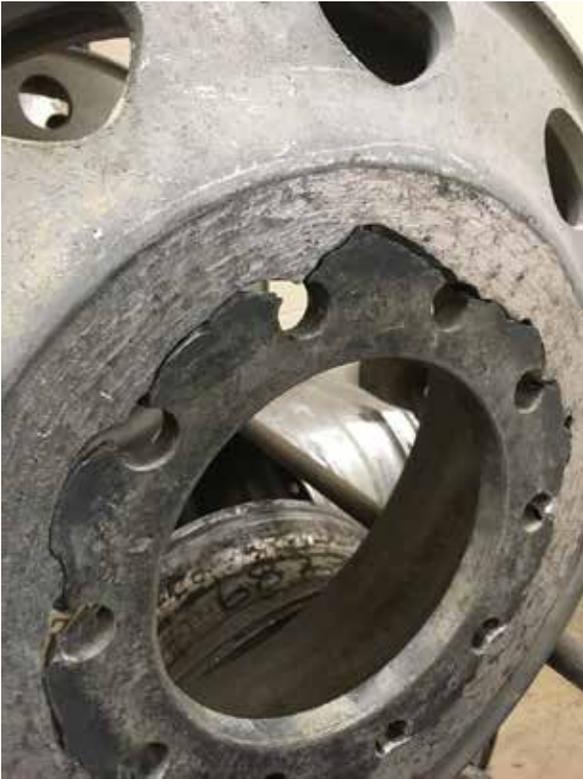
Okay. This particular one, as you can see, the wheel actually cracked the whole bolt circle, and this is another designer wheel. We don't know what the inner dual did, but we can tell you that this wheel was moving. We believe the inner dual could have been a steel wheel and basically gouged out or smoothed up the other part of this wheel. But this is one I really didn't talk to, but whenever we got it in, it was unique because the mounting flange is still intact and the other part of it is not. And to me, this looks like they run a steel wheel inner wheel and it broke and when it did, it just carved up everything that it could except the mounting flange, but it also cracked our wheels. So, when we say poor inspection protocol, this is kind of the poster child.

Yeah, it's very... If you can get on the show and look at this, it's very unique. The inner mounting circle basically stayed stationary. So that would in my mind mean that the inner wheel steel or otherwise had to break off just outside of the bolt circle and as you said, tore up the other wheel and ended up creating this crack that went around, but it stayed in place. This thing had good torque on the nuts.

So to try and explain this a little bit more, it's got, like the other guys have said, we call it the bolt circle. And the bolt circle is if you take a line, make a circle that goes from bolt hole to bolt hold to bolt hold to bolt hole, that is called the bolt circle, and that's part of the design geometry. It's how we know that our wheels are going to fit nicely onto the hub. So, we pay a lot of attention to the bolt circle. And what you've got here is, all the metal on the inside of the bolt circle from the bolt circle into the hub is perfectly in great shape. There's nothing wrong with it. But going out from the bolt circle out toward the rim, it's just tore up. There's a crack that goes 360 degrees around the wheel at the bolt circle, going from old hole to bolt hole.

And then on the mounting face there, the part that's been beat up, it looks like it's been dragged along something. That's another one that has that same sandpaper look to it. So, there was certainly movement on the inner dual, something was moving around there and just eaten up that wheel on that surface. And it is a steel wheel that didn't make it. It's the best conjecture, best explanation I can think of. I agree with what Dave said, and that makes the most sense. It's still, it's amazing the kind of the kind of damage that we're seeing on this thing.

Yeah. They were at 500-foot pounds. We've had a lot of discussions on the benefits of keeping within spec, at least they did that right.
